Steve Clarke Garages Ltd

PDI Check

Make Kia
Model Ceed
Registration OV20KWZ
Chassis No U5YH2511LLL098008
Mileage 90780

Date 16/12/2024
Service Advisor
MOT Due
Inspected By Hristo Klecharov
VHC Type PDI Check

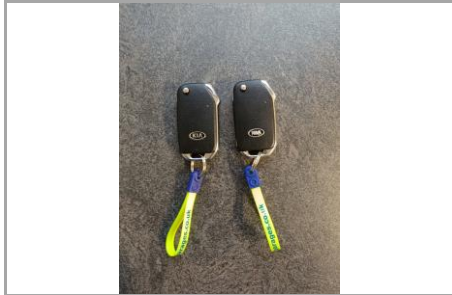
2 Keys - Image 1 of 1

G	Airbag Waring Light			
Interior Checks				
G	2 Keys			
G	Locking Wheel Nut			
G	Handbook	Yes

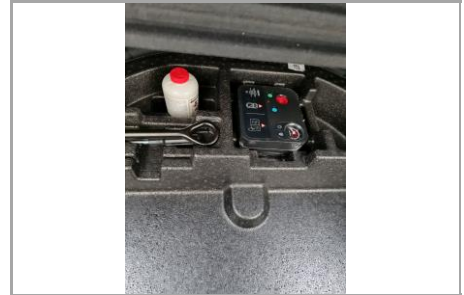
Tyre Repair Kit - Image 1 of 1

Comments / Recommendations		Net	VAT	Total
G	Vehicle has Fuel (20 miles minimum)	Yes		
G	Tyre Repair Kit			
A	Tool Kit	N/A		
Documentation				
G	V5 Registration Certificate	Yes		
G	Valid MOT	Yes		
G	HPI Checked			
G	No Outstanding Safety Recalls			
Total		0.00	0.00	0.00
