# Steve Clarke Garages Ltd

# PDI Check

Make Mazda  
Model MX-5  
Registration OU13OUH  
Chassis No JMNCA8F600264566  
Mileage 44771

Date 18/06/2026  
Service Advisor  
MOT Due 21/05/2027  
Inspected By Andy Underhill  
VHC Type PDI Check

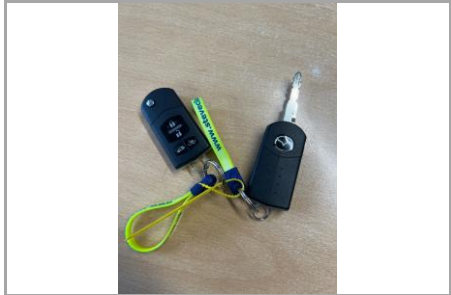
2 Keys - Image 1 of 1

| Comments / Recommendations | | Net | VAT | Total |
|---|---|---|---|---|
| G | 2 Keys | | | |

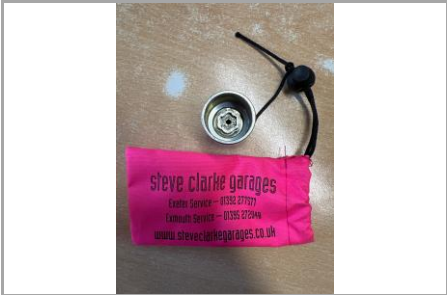
Locking Wheel Nut - Image 1 of 1

| Comments / Recommendations | | Net | VAT | Total |
|---|---|---|---|---|
| G | Locking Wheel Nut | | | |

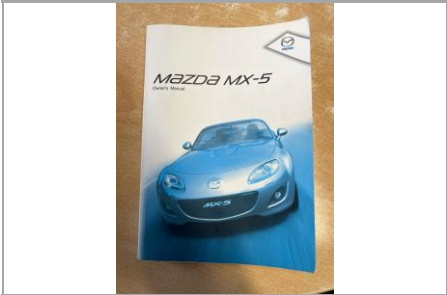
Handbook - Image 1 of 1

| Comments / Recommendations | | Net | VAT | Total |
|---|---|---|---|---|
| G | Handbook | | | |

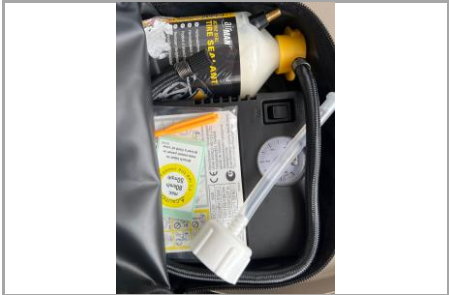
Tyre Repair Kit - Image 1 of 1

| Comments / Recommendations | | Net | VAT | Total |
|---|---|---|---|---|
| G | Tyre Repair Kit | | | |
