# Steve Clarke Garages Ltd

# PDI Check

C5 Aircross

KP72NJO

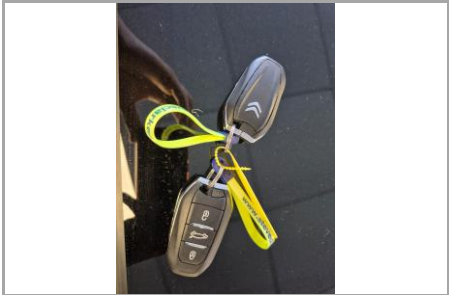
2 Keys - Image 1 of 1

| Comments / Recommendations | | Net | VAT | Total |
|---|---|---|---|---|
| G | 2 Keys | | | |

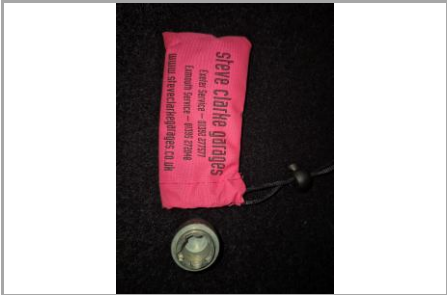
Locking Wheel Nut - Image 1 of 1

| Comments / Recommendations | | Net | VAT | Total |
|---|---|---|---|---|
| G | Locking Wheel Nut | | | |

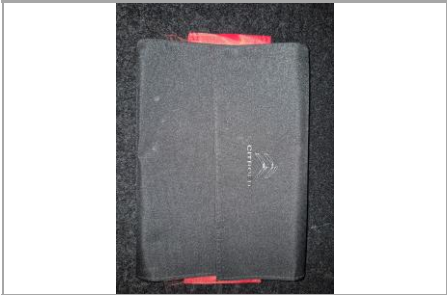
Handbook - Image 1 of 1

| Comments / Recommendations | | Net | VAT | Total |
|---|---|---|---|---|
| G | Handbook | | | |

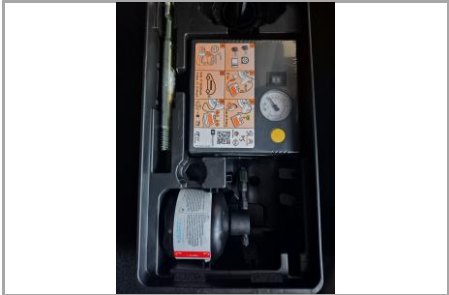
Tyre Repair Kit - Image 1 of 1

| Comments / Recommendations | | Net | VAT | Total |
|---|---|---|---|---|
| G | Tyre Repair Kit | | | |
