# Steve Clarke Garages Ltd

# PDI Check

Make Suzuki  
Model S-Cross  
Registration YB23XWG  
Chassis No TSMJYAD2S00A86191  
Mileage 63080

VHC NO 7758  
Date 27/07/2026  
Service Advisor  
MOT Due  
Inspected By Andy Underhill  
VHC Type PDI Check

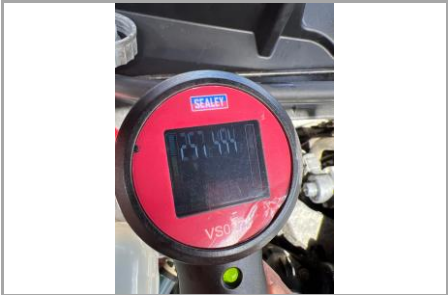
Brake Fluid Level - Image 1 of 1

| Comments / Recommendations | | Net | VAT | Total |
|---|---|---|---|---|
| G | Brake Fluid Level | | | |

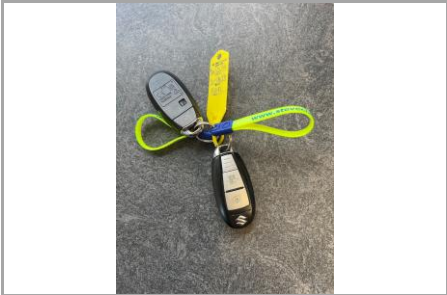
2 Keys - Image 1 of 1

| Comments / Recommendations | | Net | VAT | Total |
|---|---|---|---|---|
| G | 2 Keys | | | |

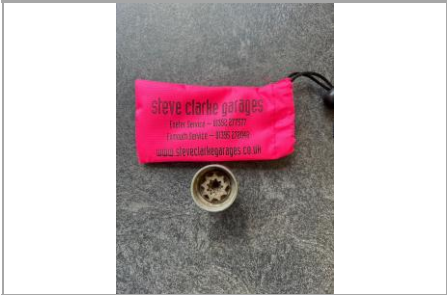
Locking Wheel Nut - Image 1 of 1

| Comments / Recommendations | | Net | VAT | Total |
|---|---|---|---|---|
| G | Locking Wheel Nut | | | |

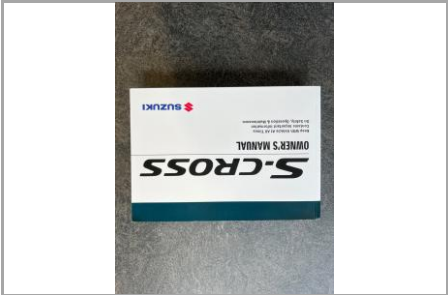
Handbook - Image 1 of 1

| Comments / Recommendations | | Net | VAT | Total |
|---|---|---|---|---|
| G | Handbook | | | |

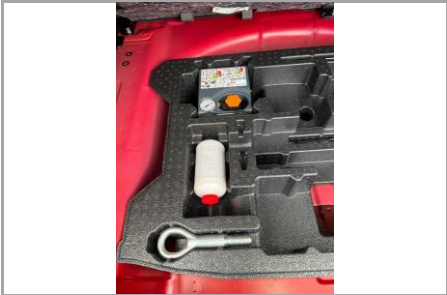
Tyre Repair Kit - Image 1 of 1

| Comments / Recommendations | | Net | VAT | Total |
|---|---|---|---|---|
| G | Tyre Repair Kit | | | |
