Steve Clarke Garages Ltd

PDI Check

Make Renault
Model Captur
Registration YHZ8755
Chassis No VF1RJB00269272486
Mileage 15250

Date 19/12/2025
Service Advisor
MOT Due
Inspected By Hristo Klecharov
VHC Type PDI Check

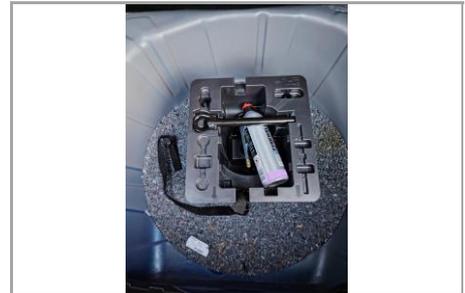
Tyre Repair Kit - Image 1 of 1

Comments / Recommendations		Net	VAT	Total
G	Vehicle has Fuel (20 miles minimum)	Yes		
G	Tyre Repair Kit			
A	Tool Kit	N/A		
Documentation				
G	V5 Registration Certificate	Yes		
G	Valid MOT	Yes		
G	HPI Checked	Mfl		
G	No Outstanding Safety Recalls			
Total		0.00	0.00	0.00
