# Steve Clarke Garages Ltd

# Vehicle Health Check

Sandero Stepway

WG68LVU

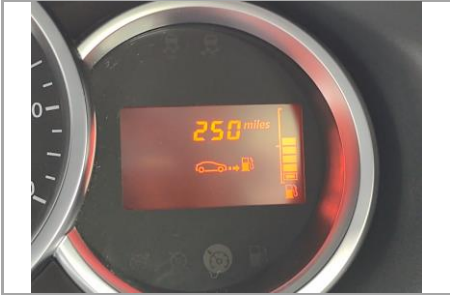
Vehicle has Fuel (20 miles minimum) -
