Vehicle Health Check

Make **MINI**
Model **Hatch**
Registration **WD16EHK**
Chassis No **WMWXN320003C48780**
Mileage **57836**

Date **08/10/2020**
Service Advisor
MOT Due
Inspected By **Charlie Wardale**

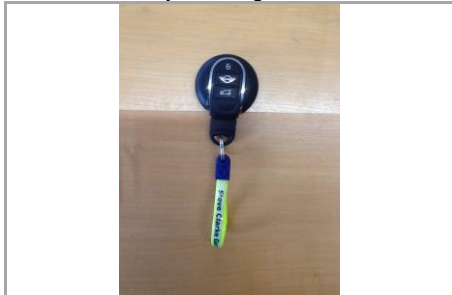
2 Keys - Image 1 of 1

Interior Checks				
A	2 Keys	1 Key		
G	Locking Wheel Nut			
G	Handbook			
G	Vehicle has Fuel (20 miles minimum)			
G	Tyre Repair Kit			
A	Tool Kit	N/a
